New York House Inspectors
(516) 551-2422
newyorkhouseinspectors.com

Home Inspection Report

123 Example Ln

Inspected On Fri, Jun 17, 2022 at 8:00 AM

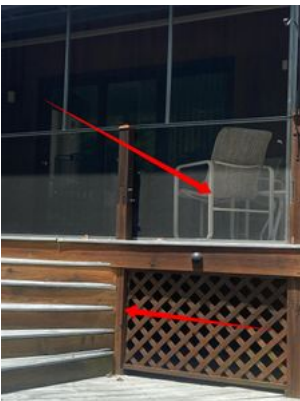
Comment 1

Guardrail missing on step wonders and upper deck. Install appropriate protection to prevent falls.

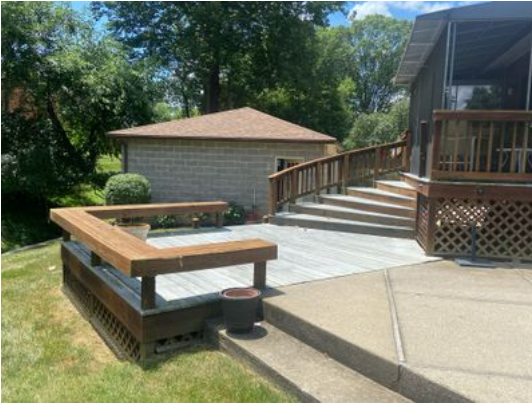
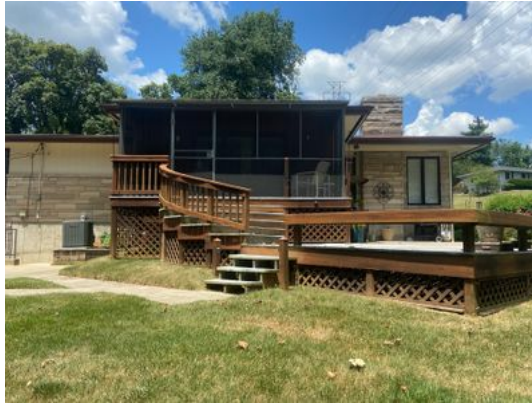
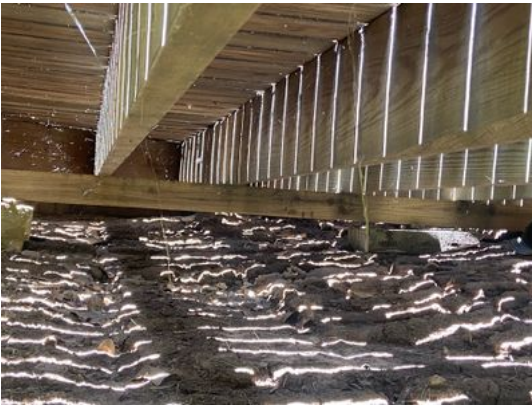
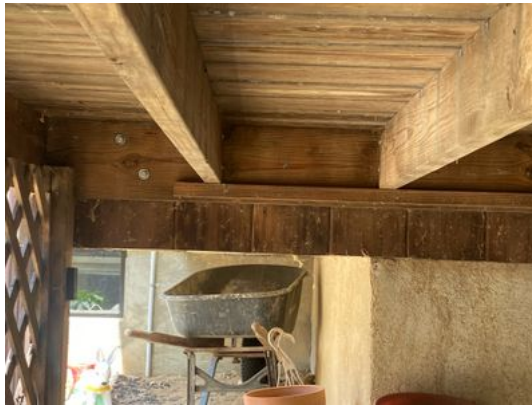
Comment 2

Deck has been well maintained and is acceptable condition.

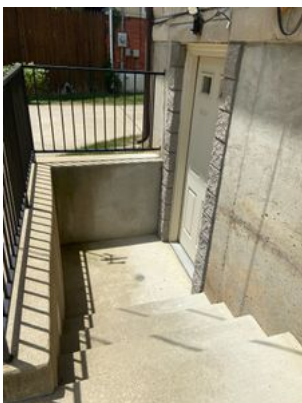
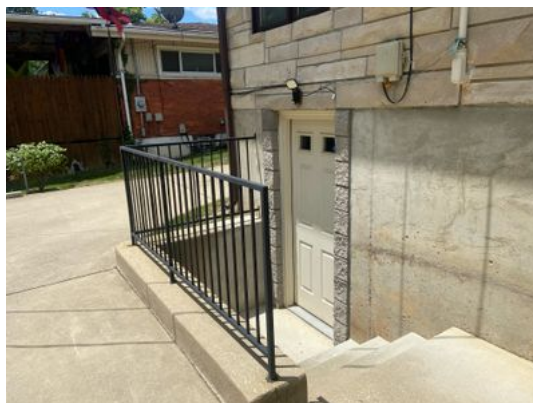
Comment 3

Handrail missing at basement exterior entry. Install for safety.

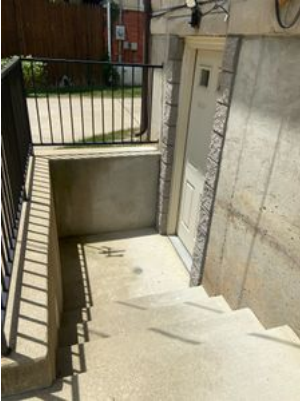
Comment 4

Keep basement entry drain clear of debris or water will come in through door.

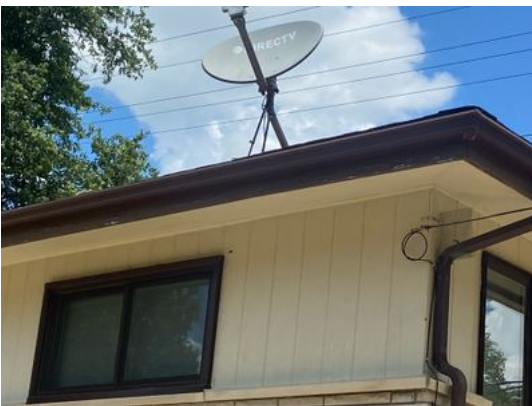
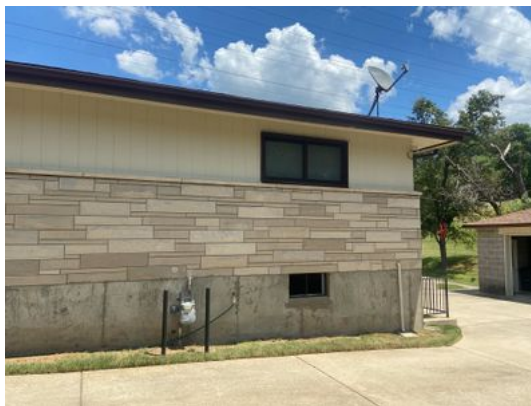
Comment 5

Exterior wood trim has peeling paint and possible minor wood damage. Repair, prep and paint to prevent wood from rotting.

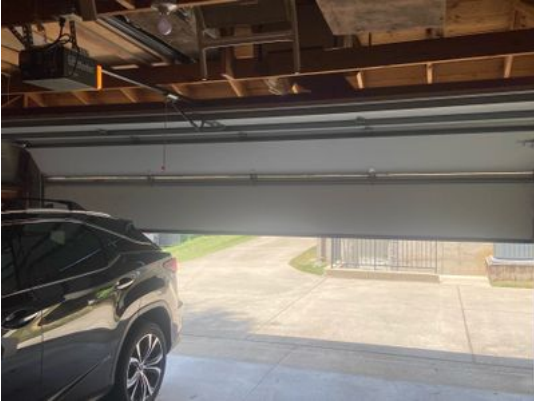
Comment 6 Information

Vehicle door and opener operates as expected.

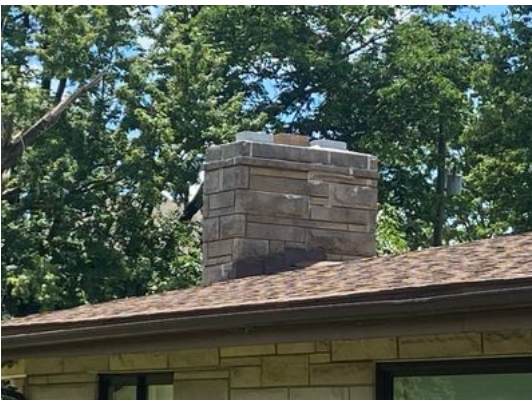
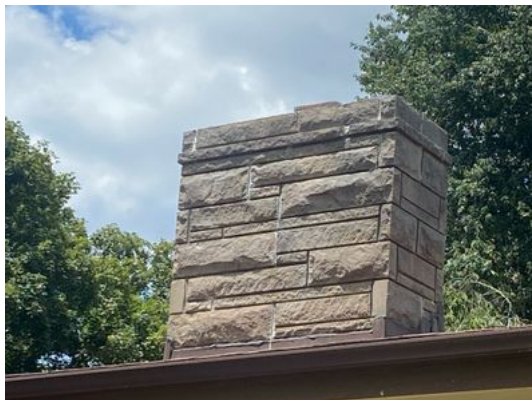
Comment 7

Prior repairs visible to chimney mortar and bricks. Monitor for signs of future water penetration and address if needed.

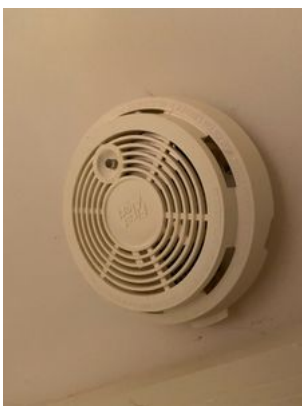
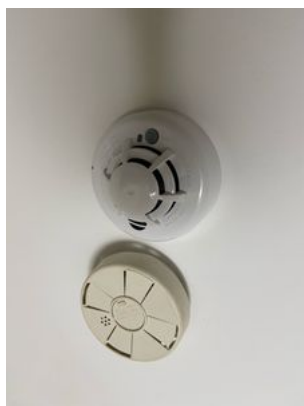
Comment 8

Smoke detectors are 9 volt type. Replace with 10 year lithium type or hard wired smoke detectors on each occupied level.

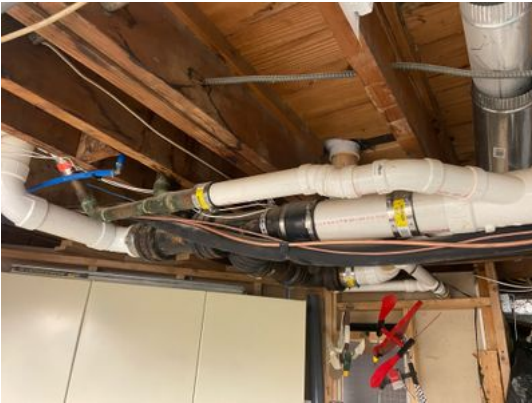
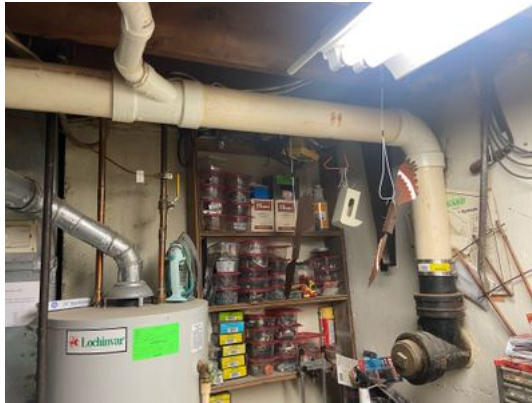
Comment 10 Information

Easter lives have been mostly replaced with pvc. Ok.

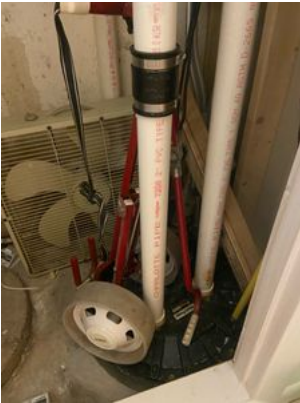
Comment 11 Information

Sewage ejector installed in basement. Do not use basement plumbing when power is out and be careful what is flushed. No wipes or hygiene products.

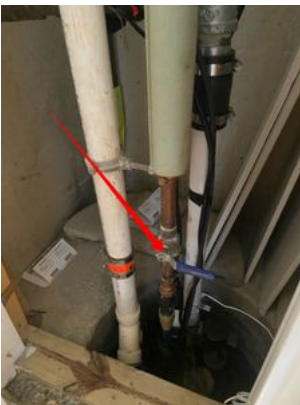
Comment 12

Water driven backup sump pump at rear right sump is not functioning. Repair or replace by licensed plumber.

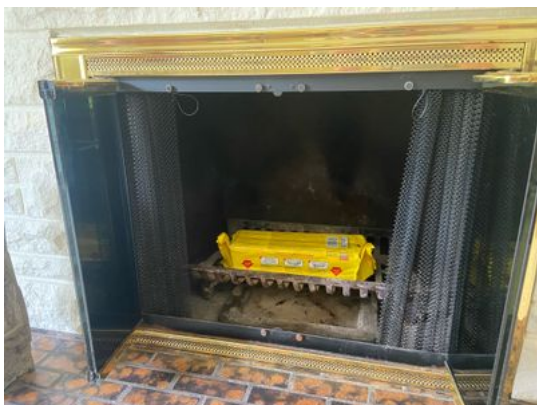
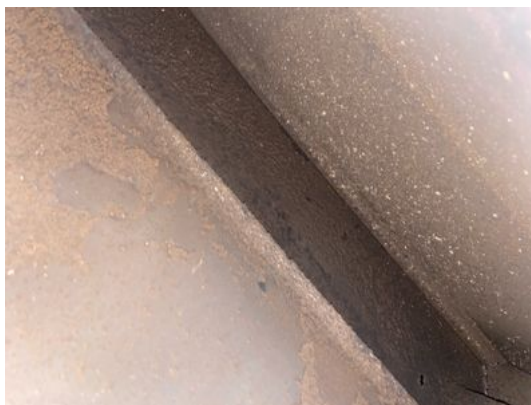
Comment 14

Fireplace flue appears very dirty. Have cleaned by chimney sweep before use for safety.

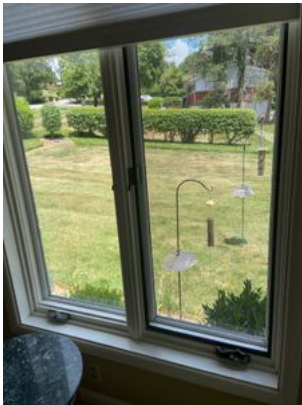
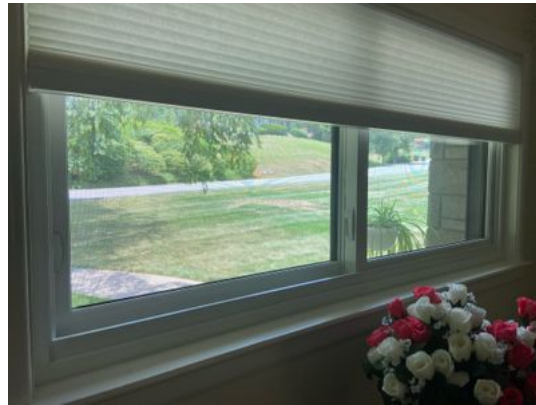
Comment 15

Original Windows have been replaced with vinyl thermopane types. Operate as expected. Ok.

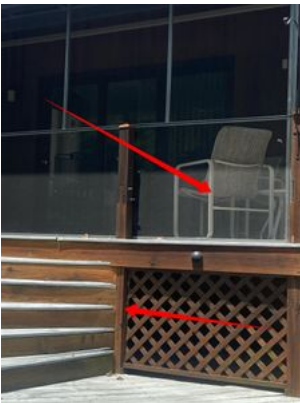
Site

Guardrail missing on step wonders and upper deck. Install appropriate protection to prevent falls.

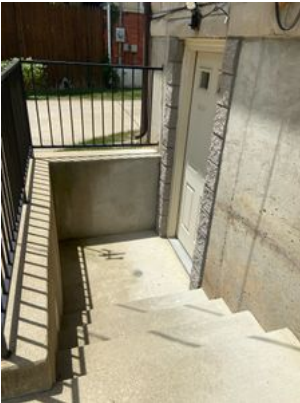
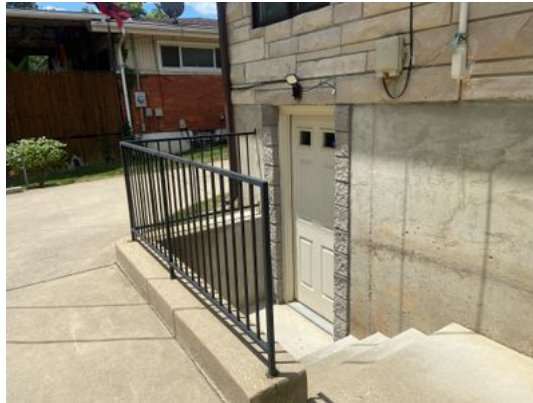
Exterior: Railings

Handrail missing at basement exterior entry. Install for safety.

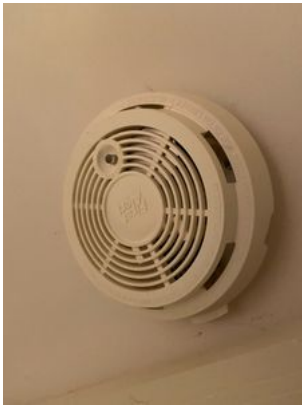
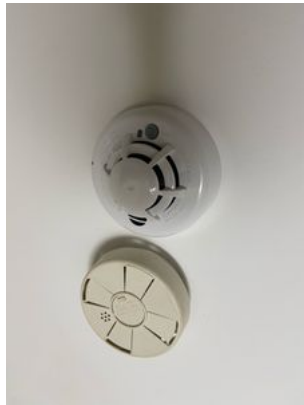
Electrical

Smoke detectors are 9 volt type. Replace with 10 year lithium type or hard wired smoke detectors on each occupied level.

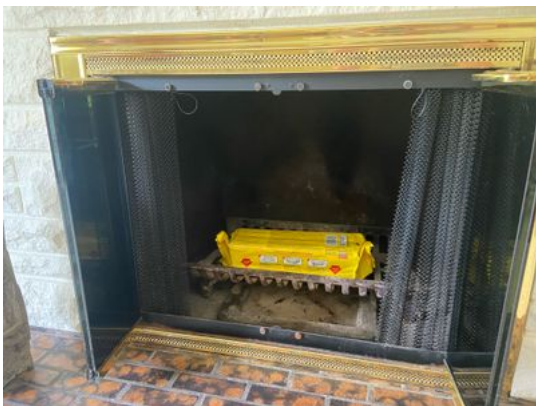
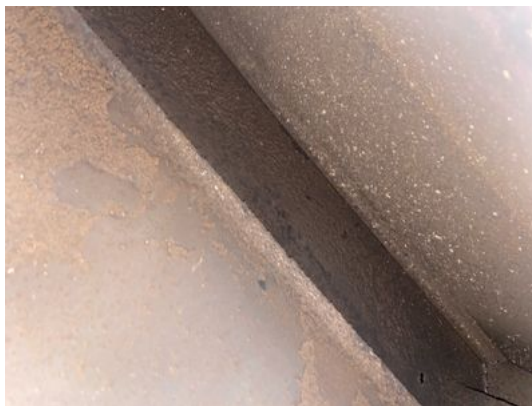
Interior: Fireplace

Fireplace flue appears very dirty. Have cleaned by chimney sweep before use for safety.

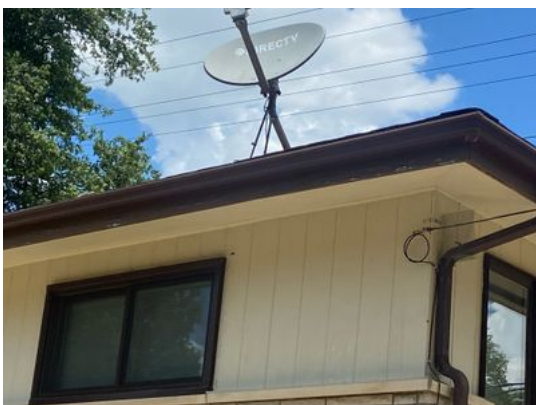
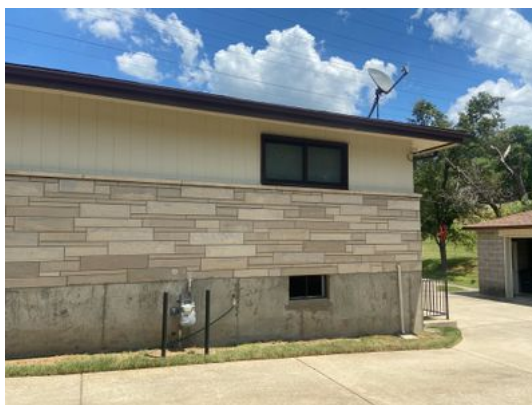
Exterior wood trim has peeling paint and possible minor wood damage. Repair, prep and paint to prevent wood from rotting.

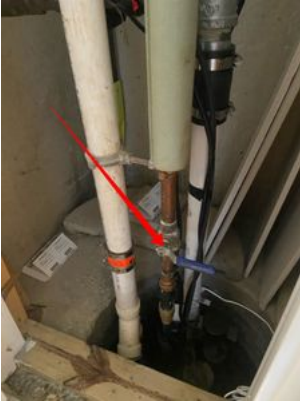
Plumbing

Water driven backup sump pump at rear right sump is not functioning. Repair or replace by licensed plumber.
