New York House Inspectors
(516) 551-2422
newyorkhouseinspectors.com

Home Inspection Report

123 Example Ln

Inspected On Fri, Jun 17, 2022 at 8:00 AM

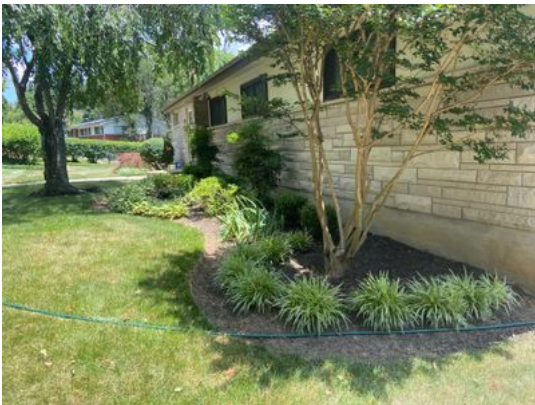
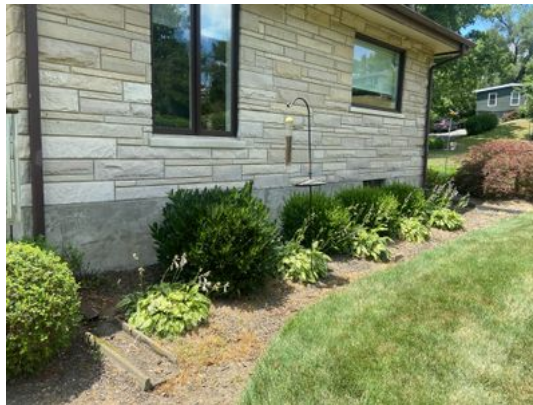
Condition: Satisfactory

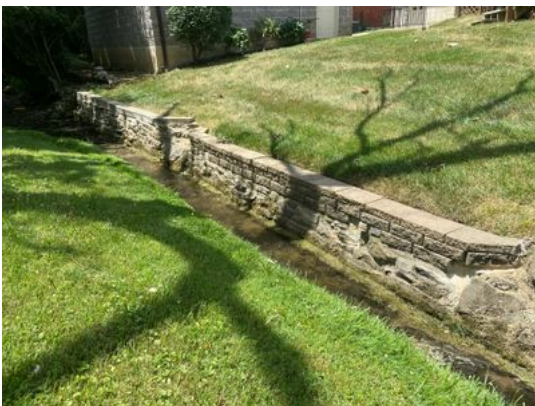
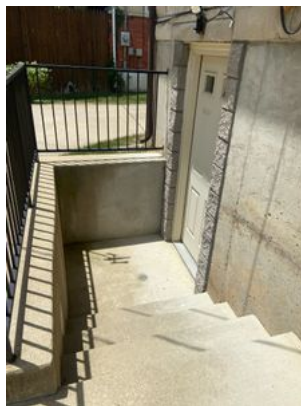
Retaining Walls

Condition: Satisfactory

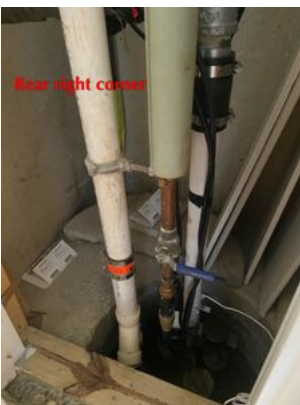
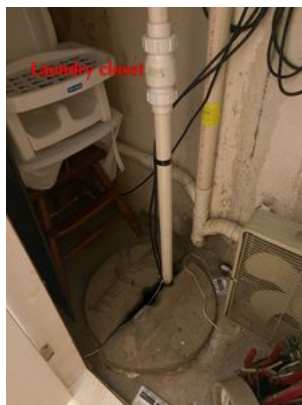
Both sump pumps (one by laundry, one at rear right corner) operate as expected.
